U.S. Department  
of Transportation

National Highway  
Traffic Safety  
Administration

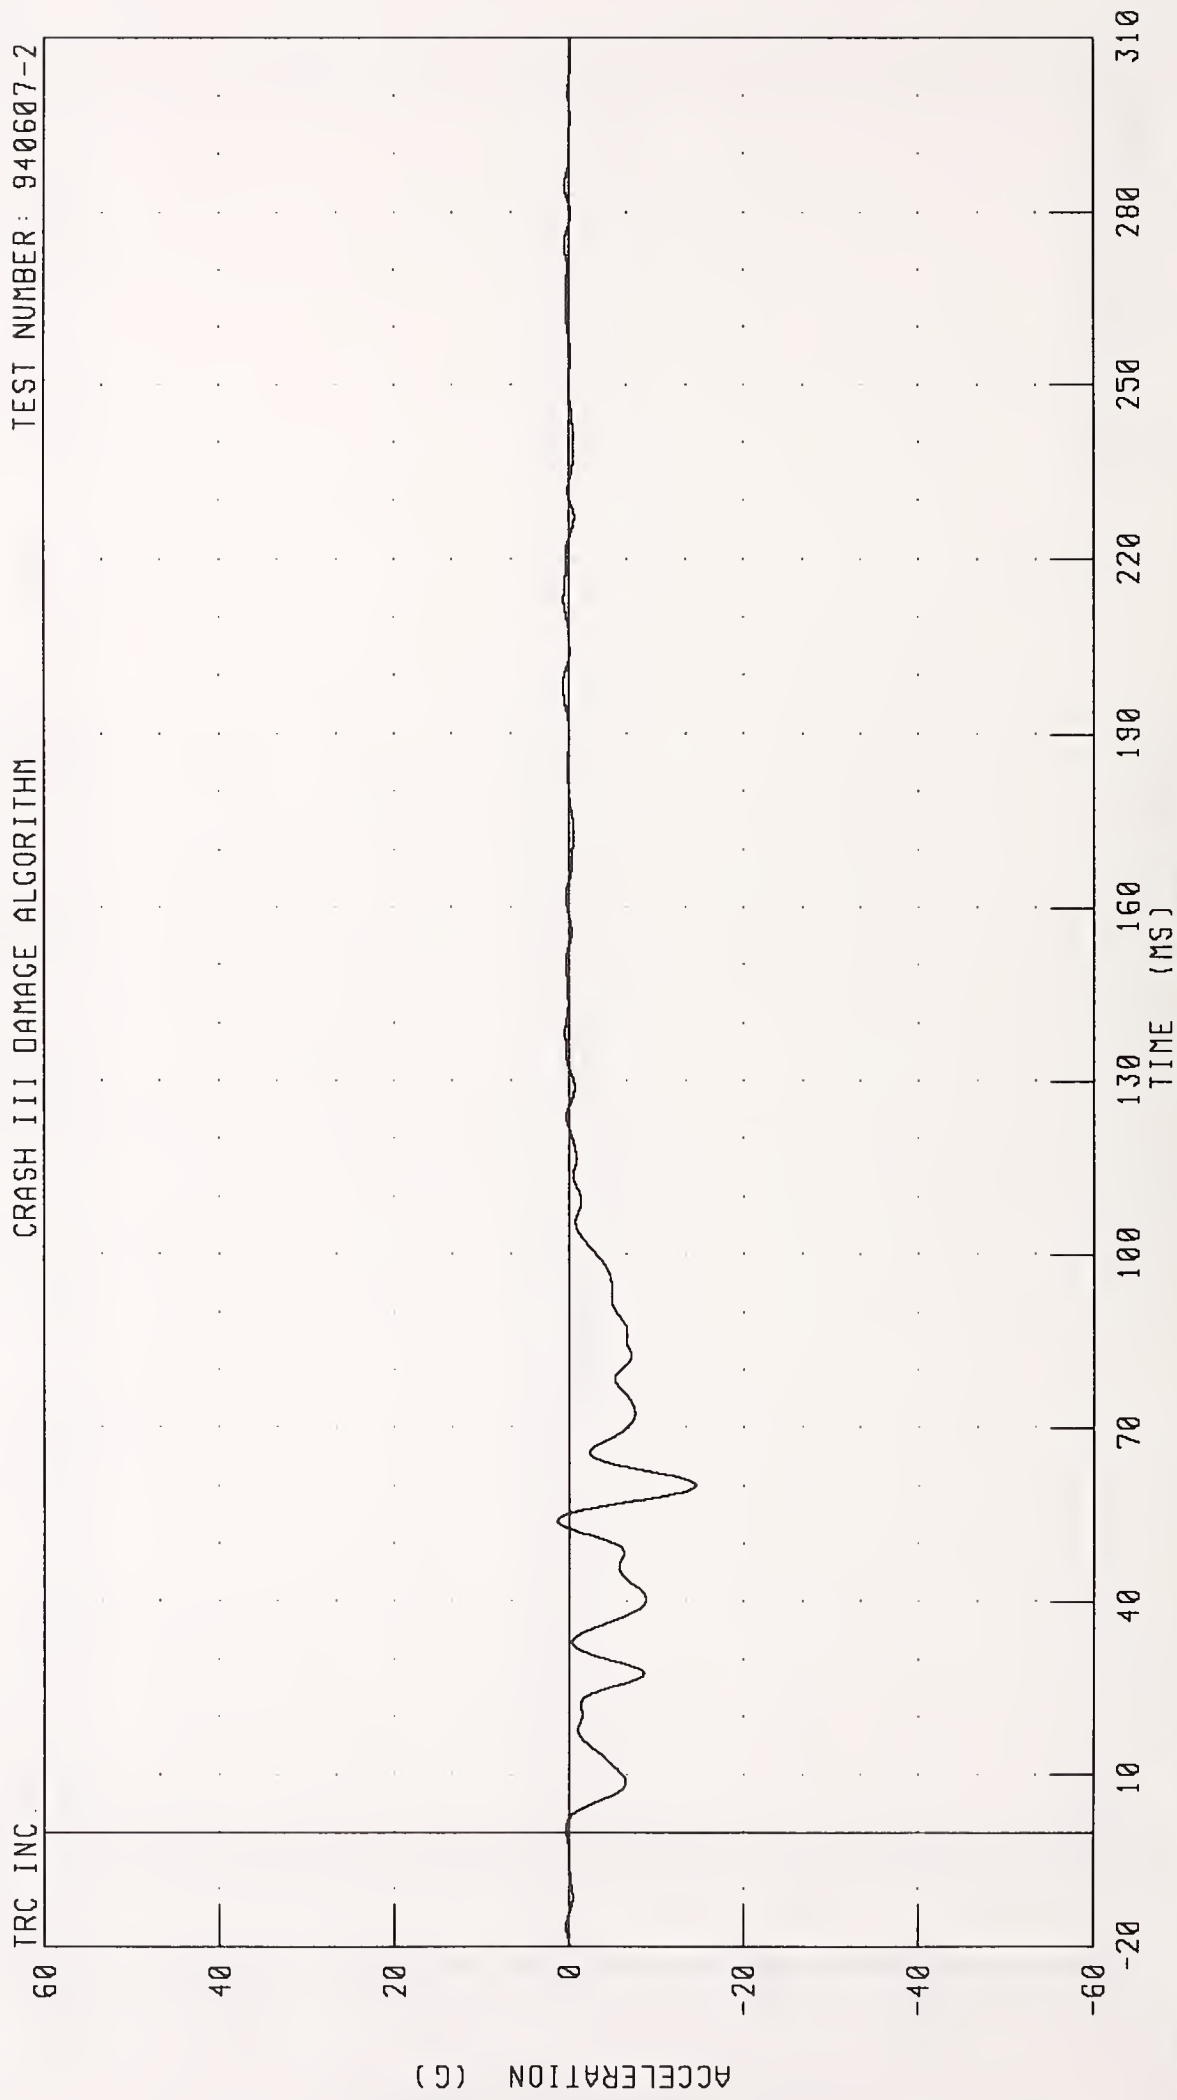
CHANNEL: RRSXG1 FILTER: CH. CLASS 60

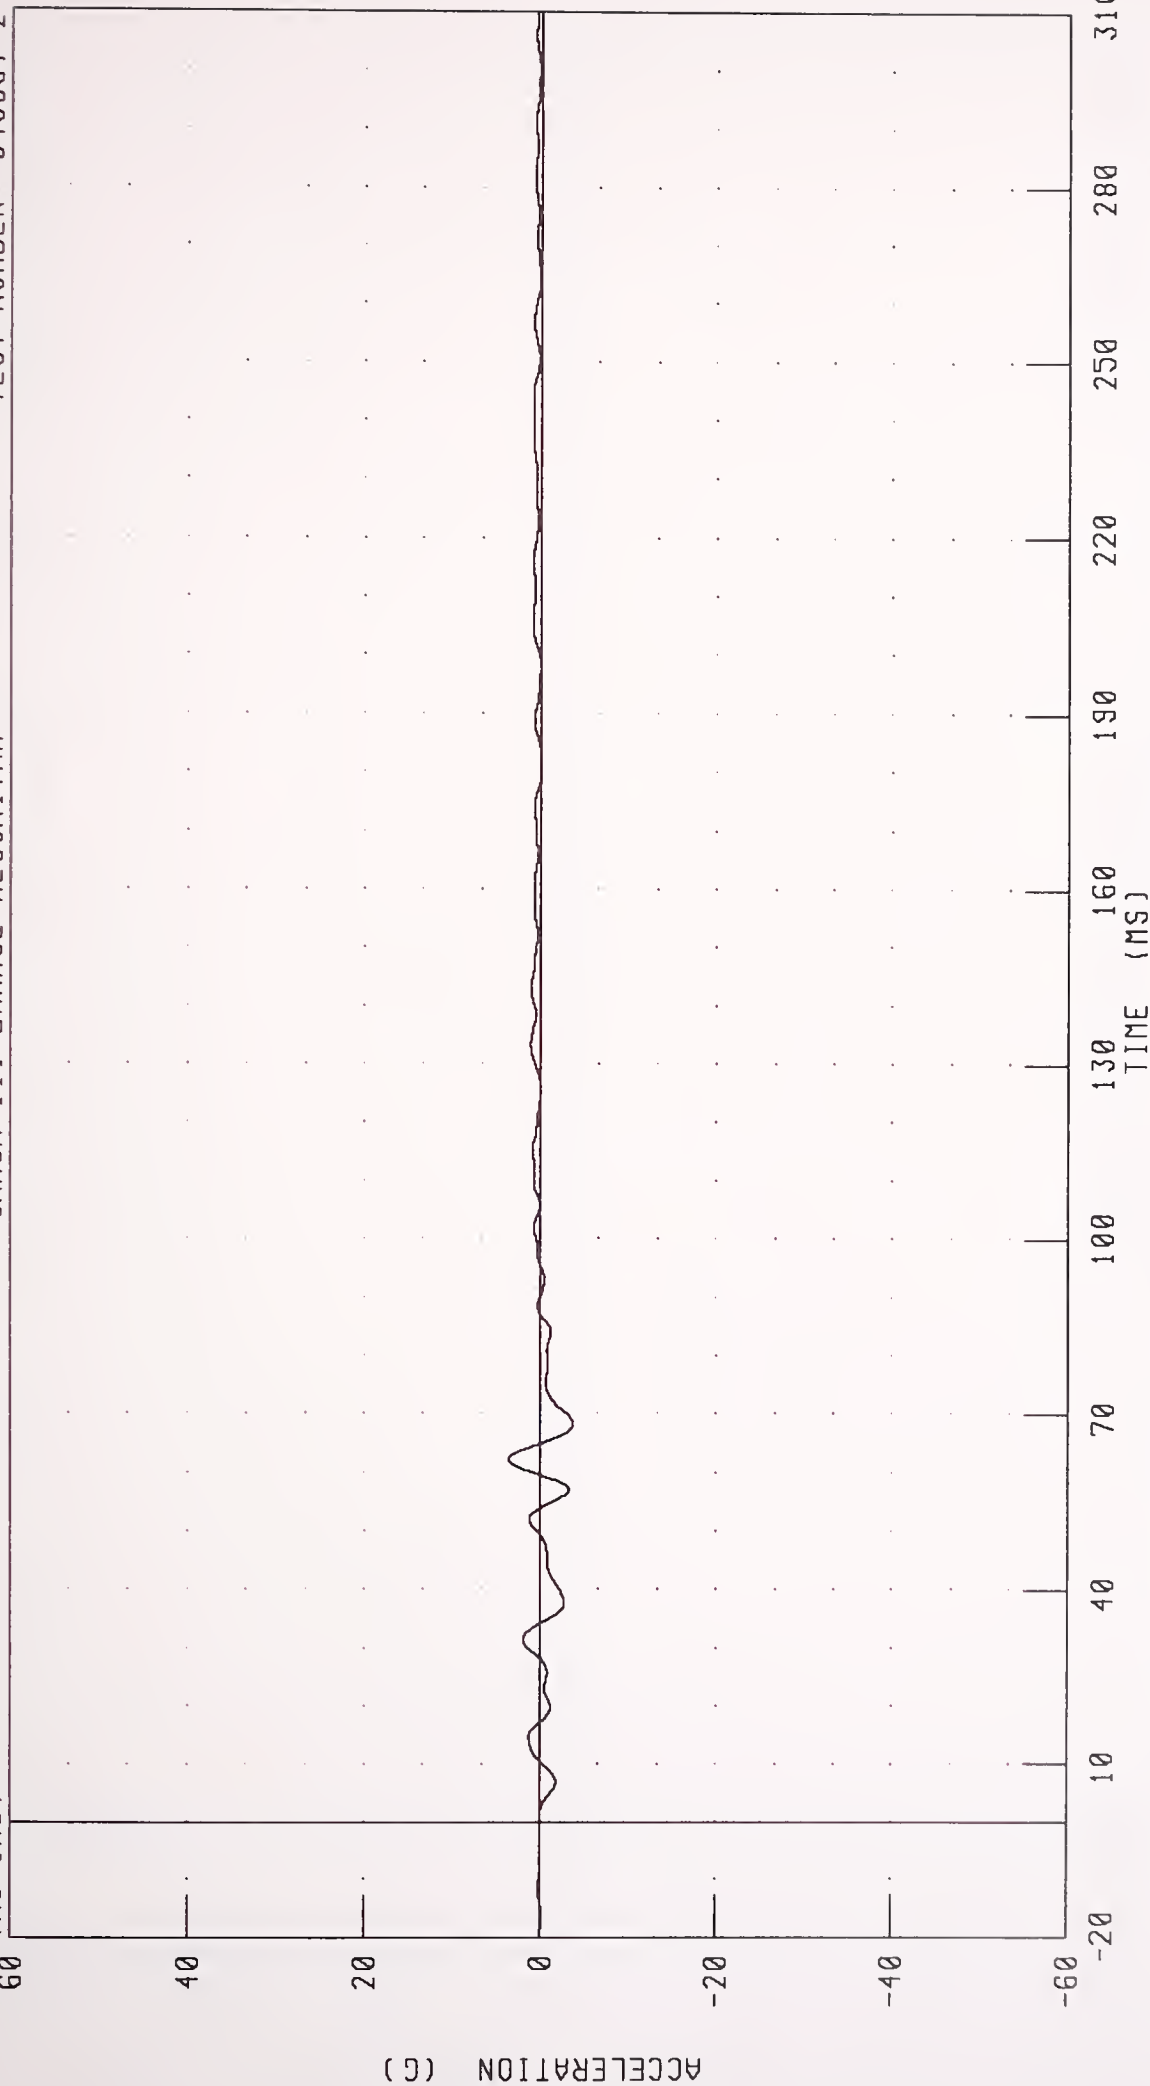
CHANNEL: RRSYG1 FILTER: CH. CLASS 60

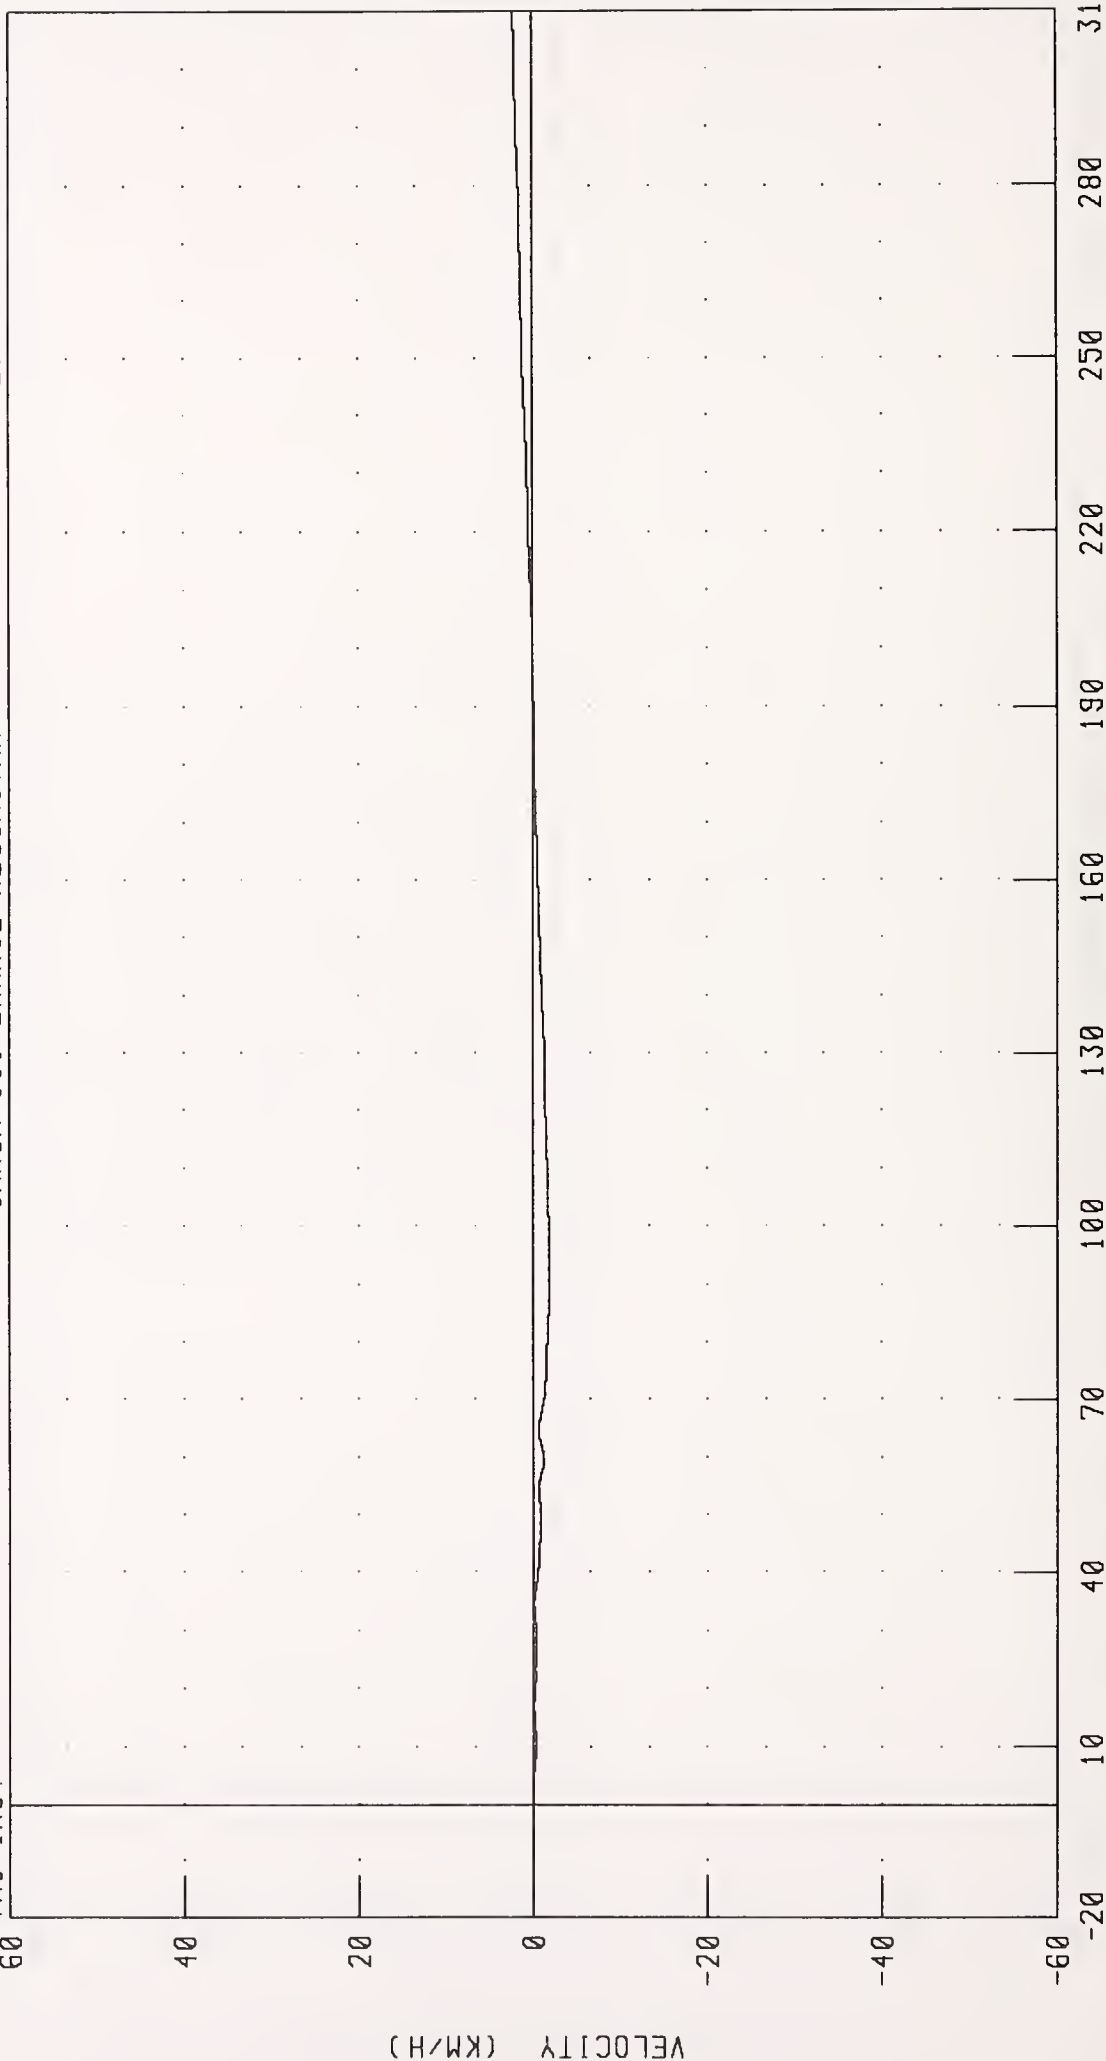
CHANNEL: RRSYV1 FILTER: CH. CLASS 180

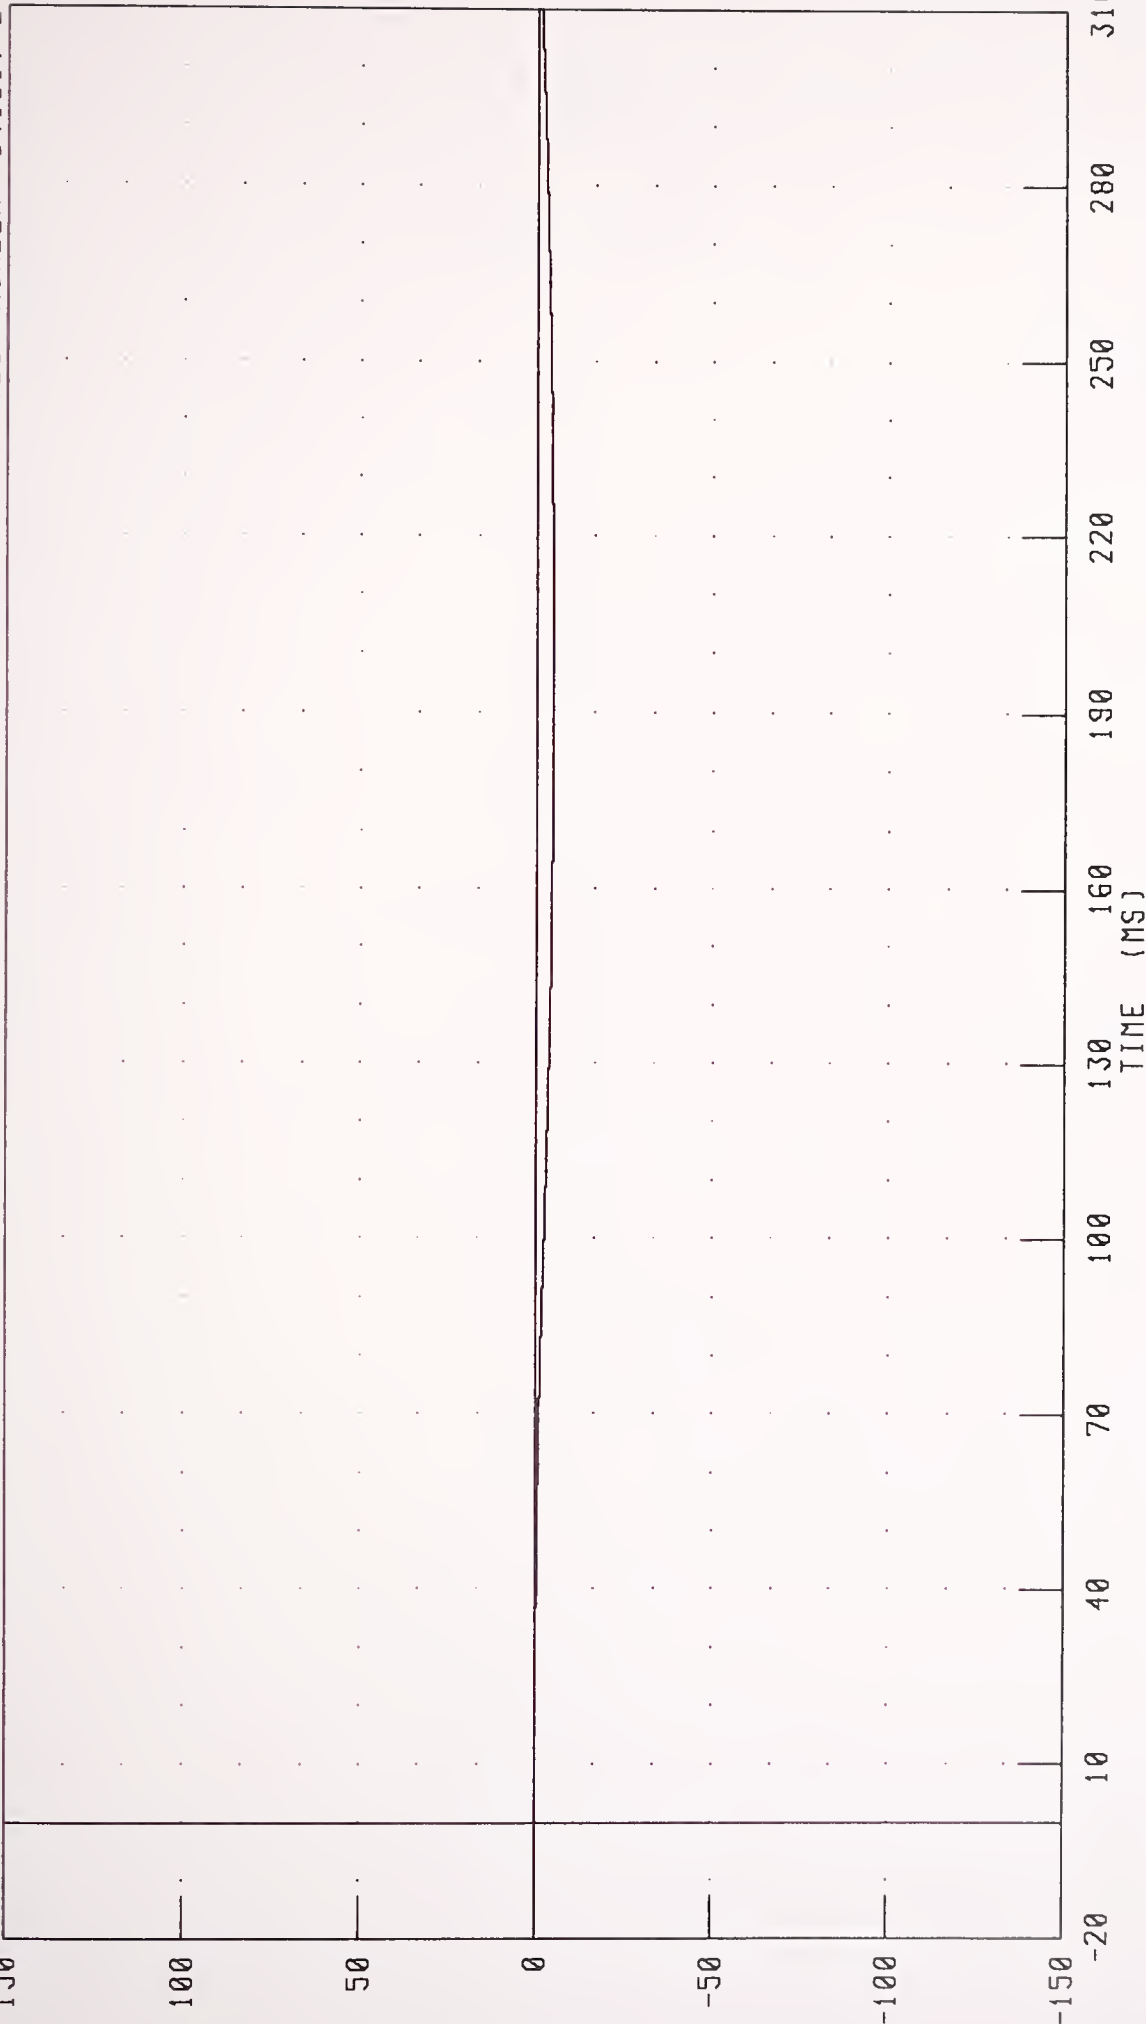
CHANNEL: RRSYD1 FILTER: CH. CLASS 180 PEAK DATA: 0.00 MM @ 0.00 MS; -46.21 MM @ 202.24 MS

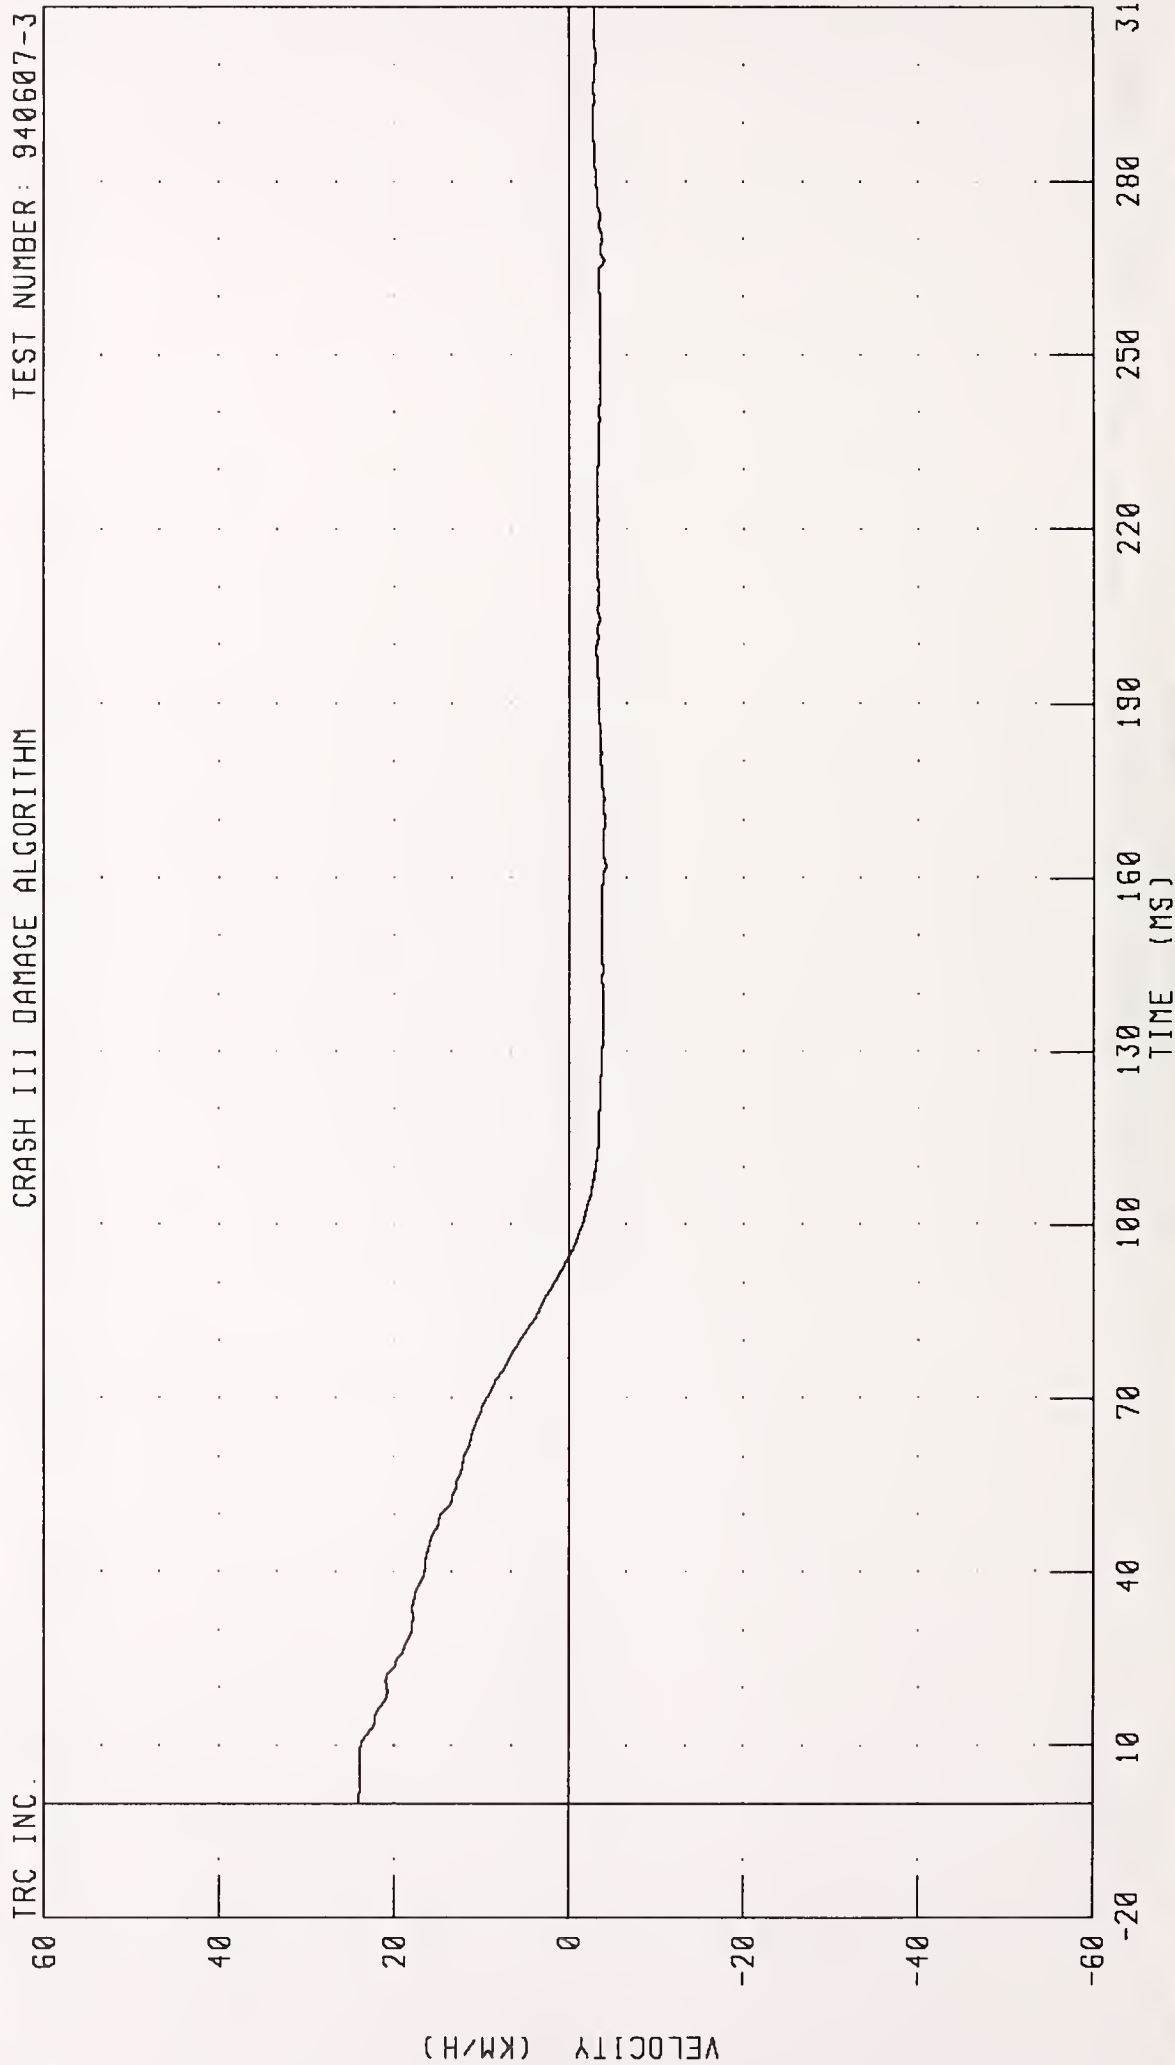
CHANNEL: VCGXV1 FILTER: CH. CLASS 180

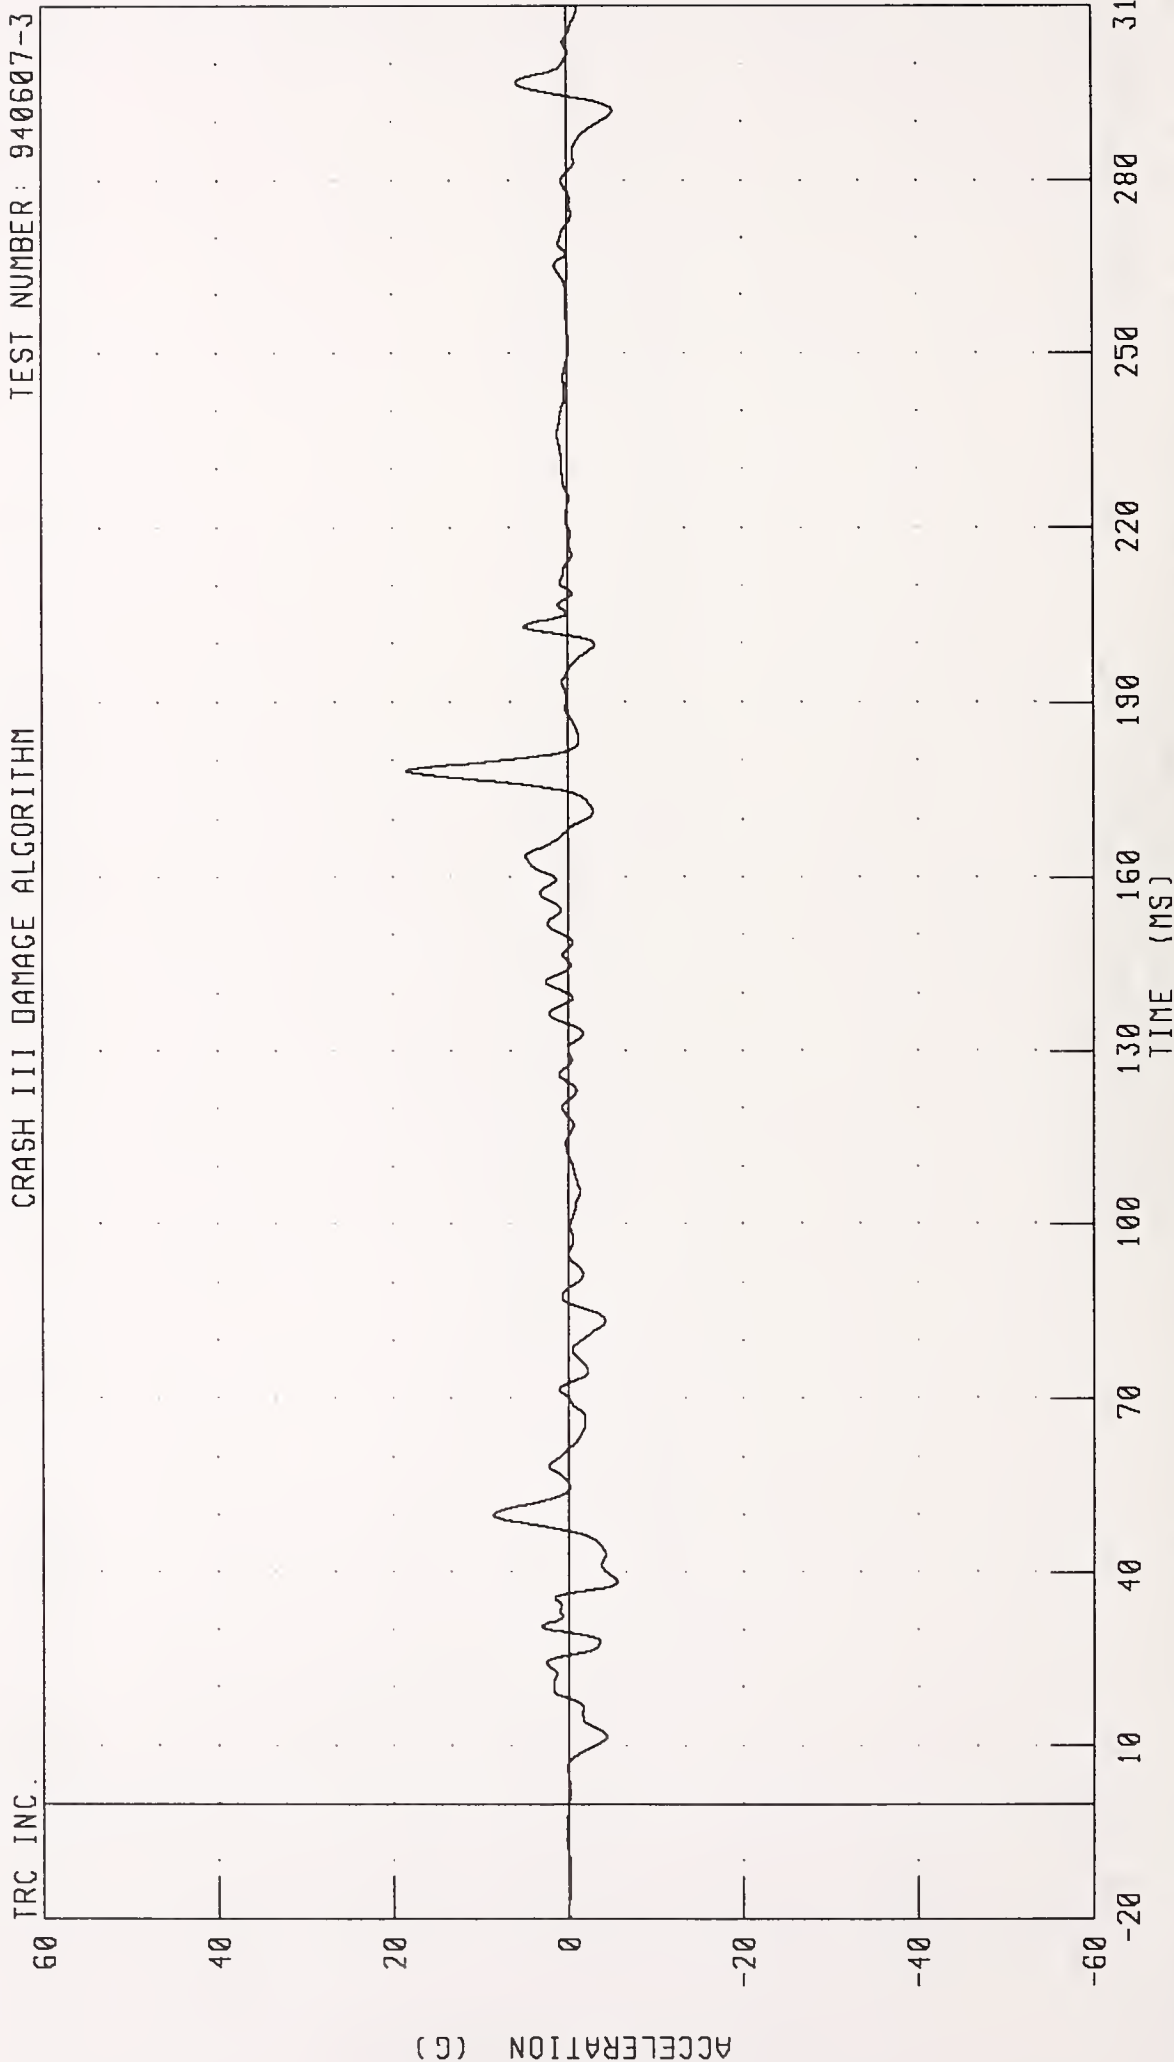
CHANNEL: VCGYG1 FILTER: CH. CLASS 60

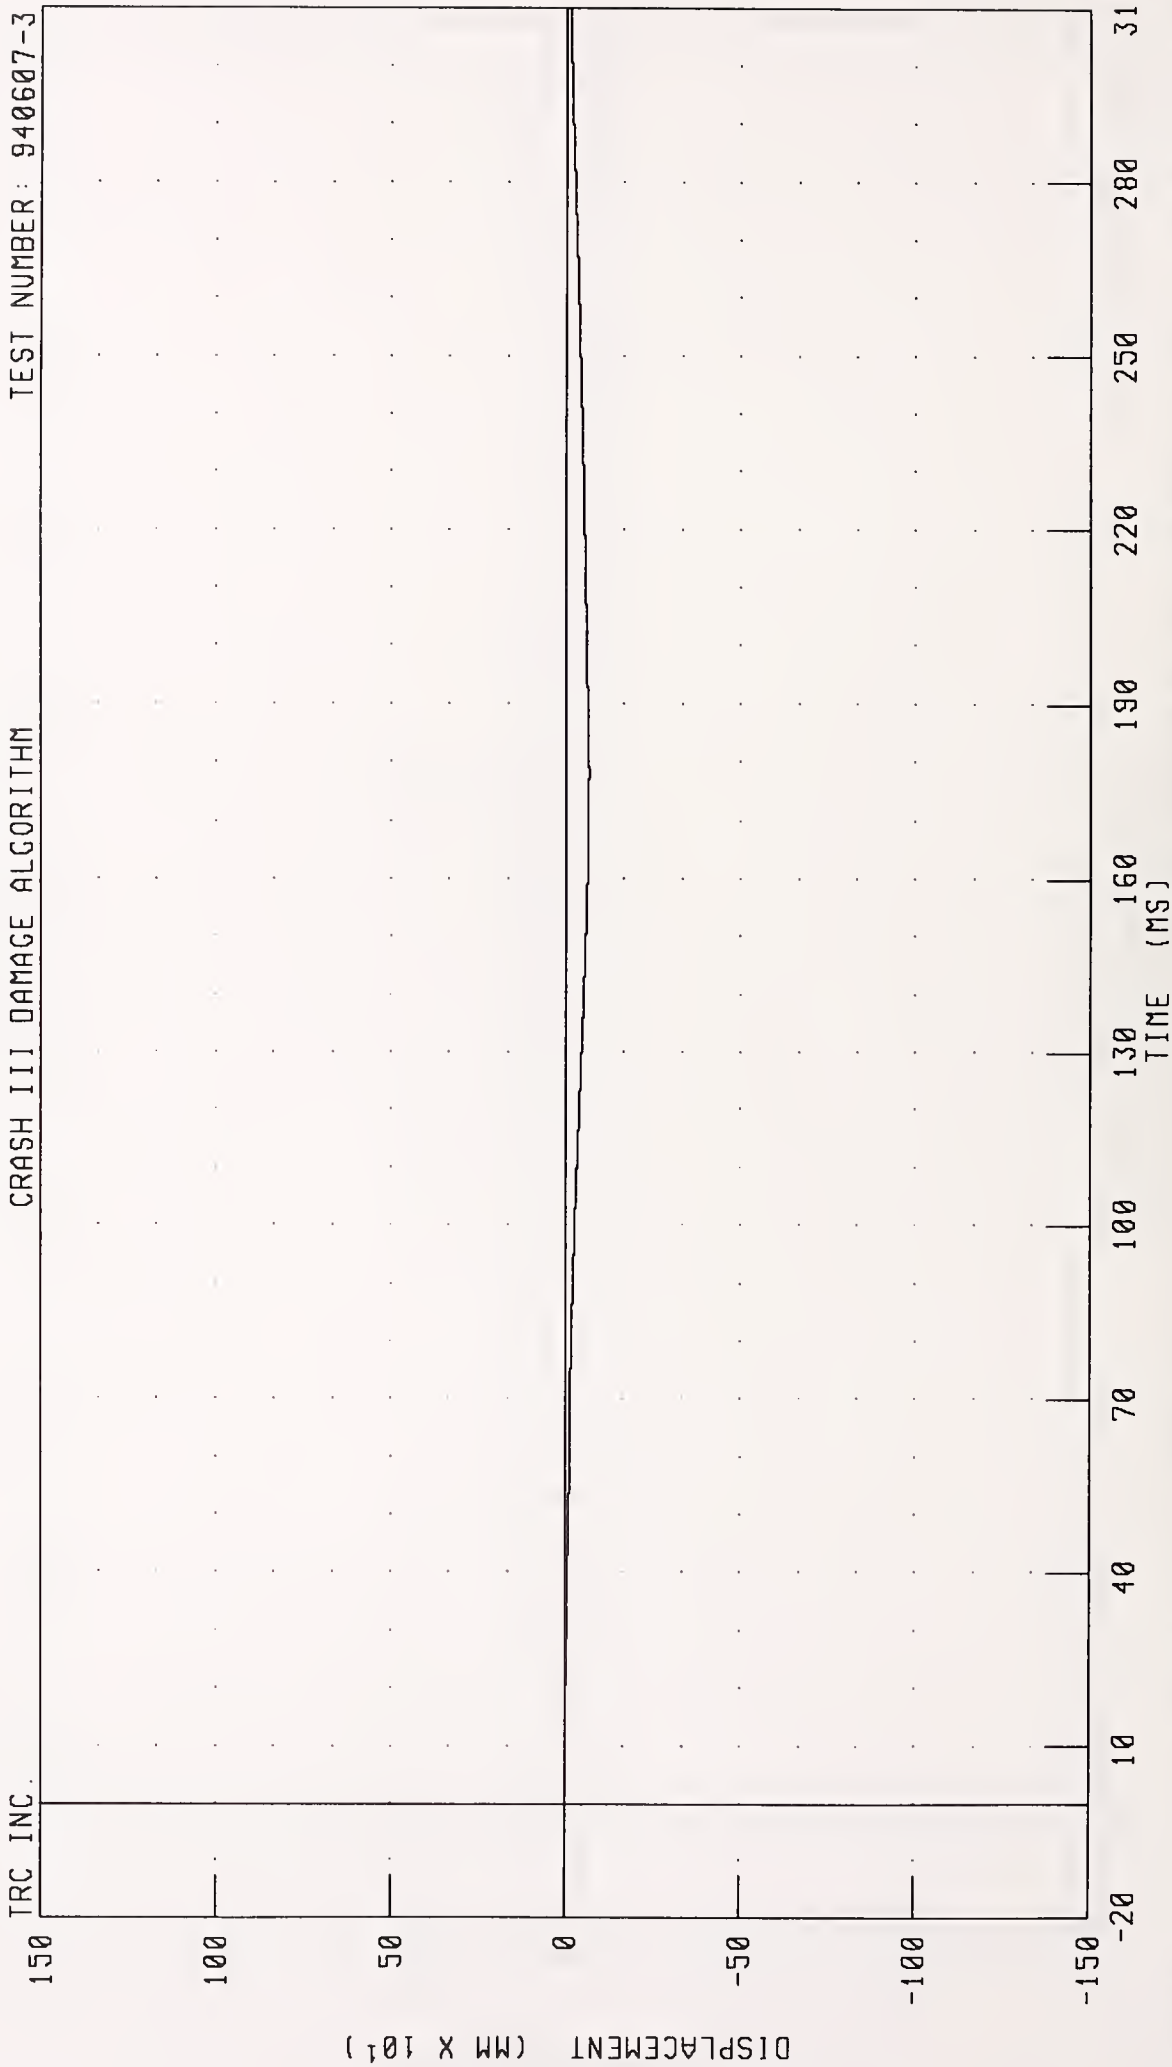
CHANNEL: VCGYD1 FILTER: CH. CLASS 180

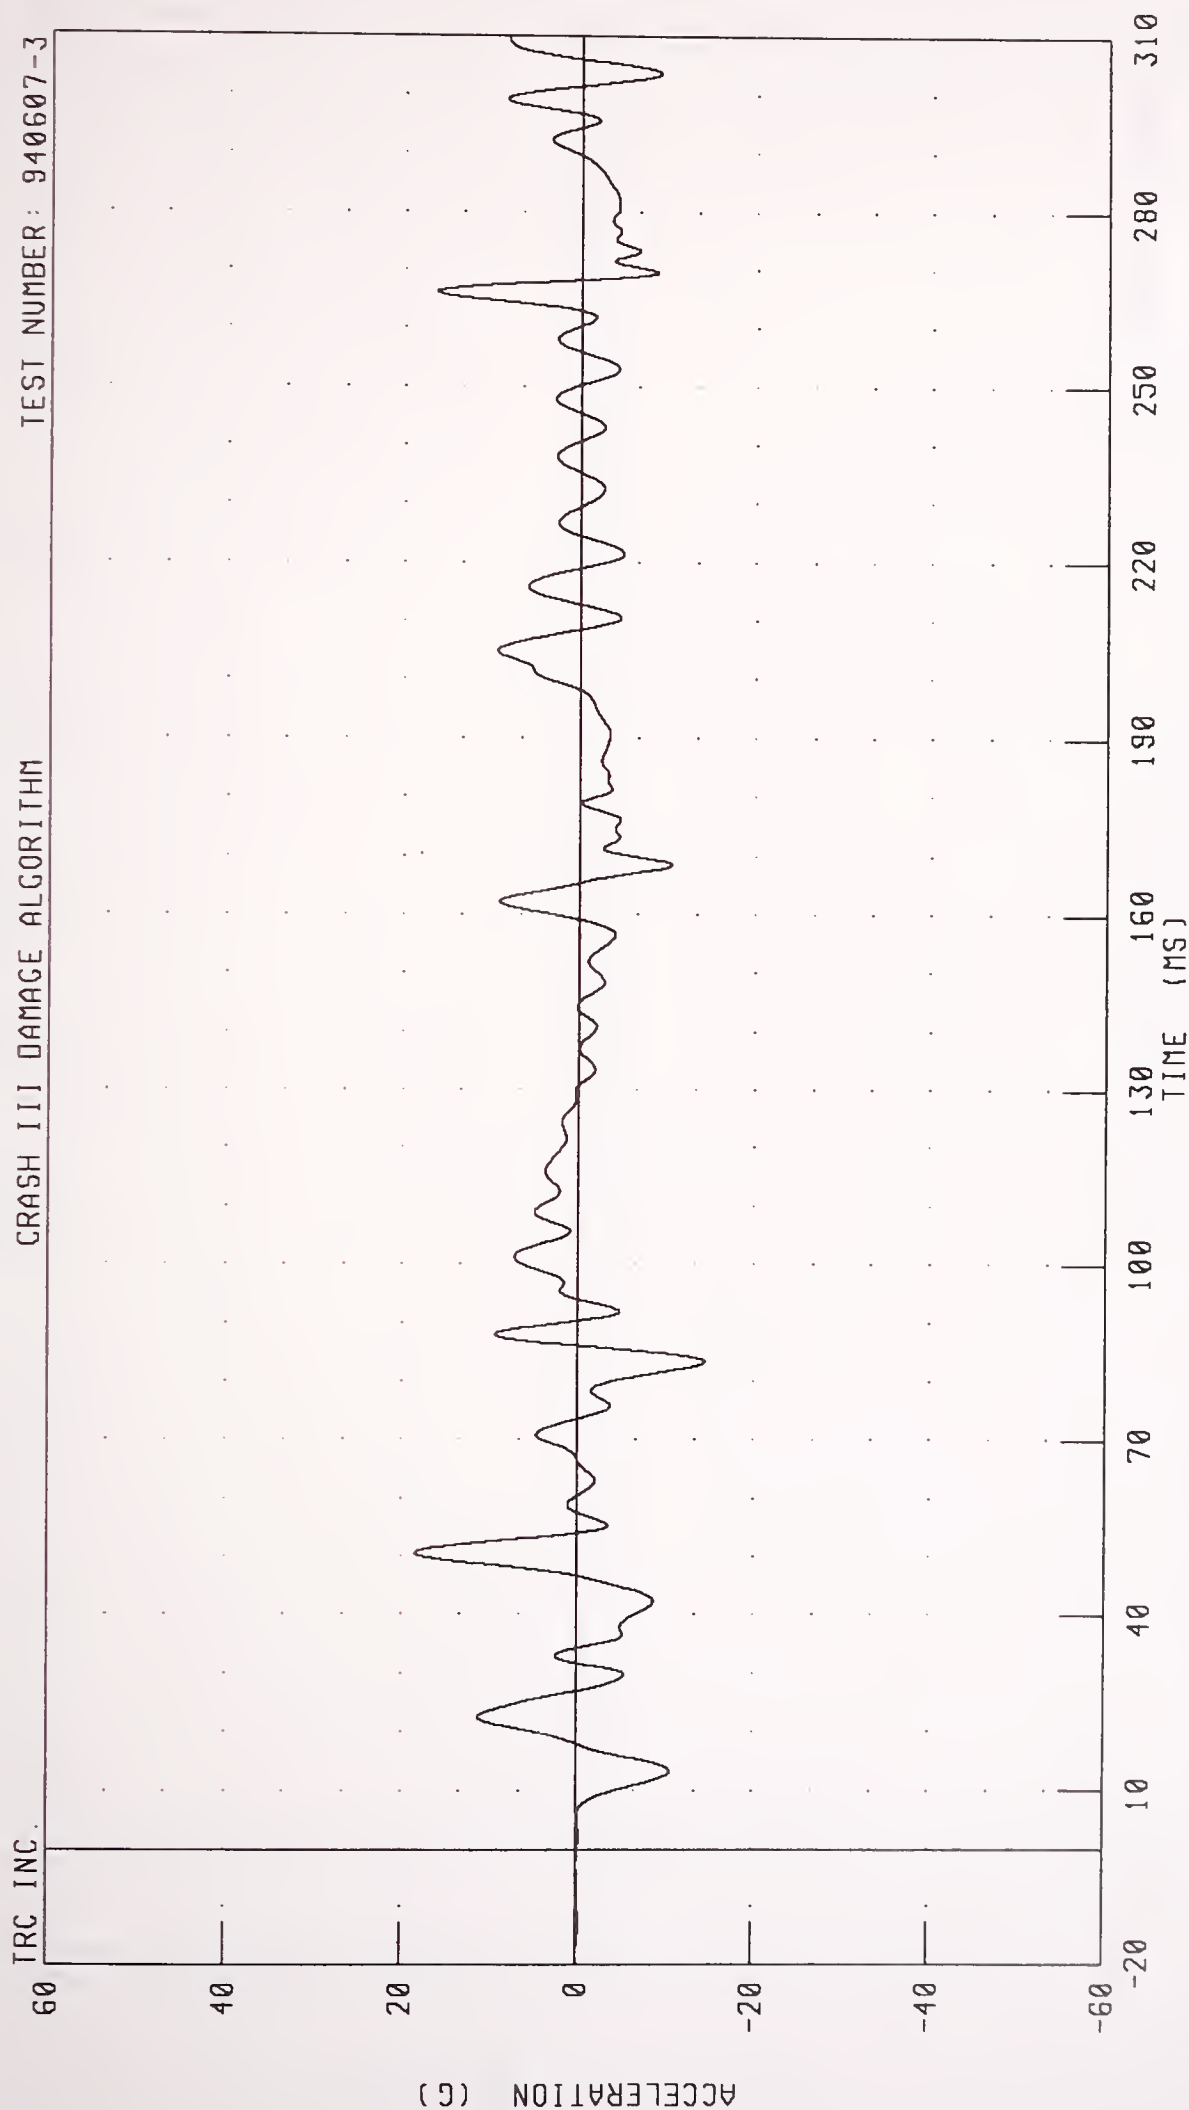
CHANNEL: VCGZG1 FILTER: CH. CLASS 60 PEAK DATA: 18.42 G @ 50.64 MS; -14.51 G @ 83.44 MS

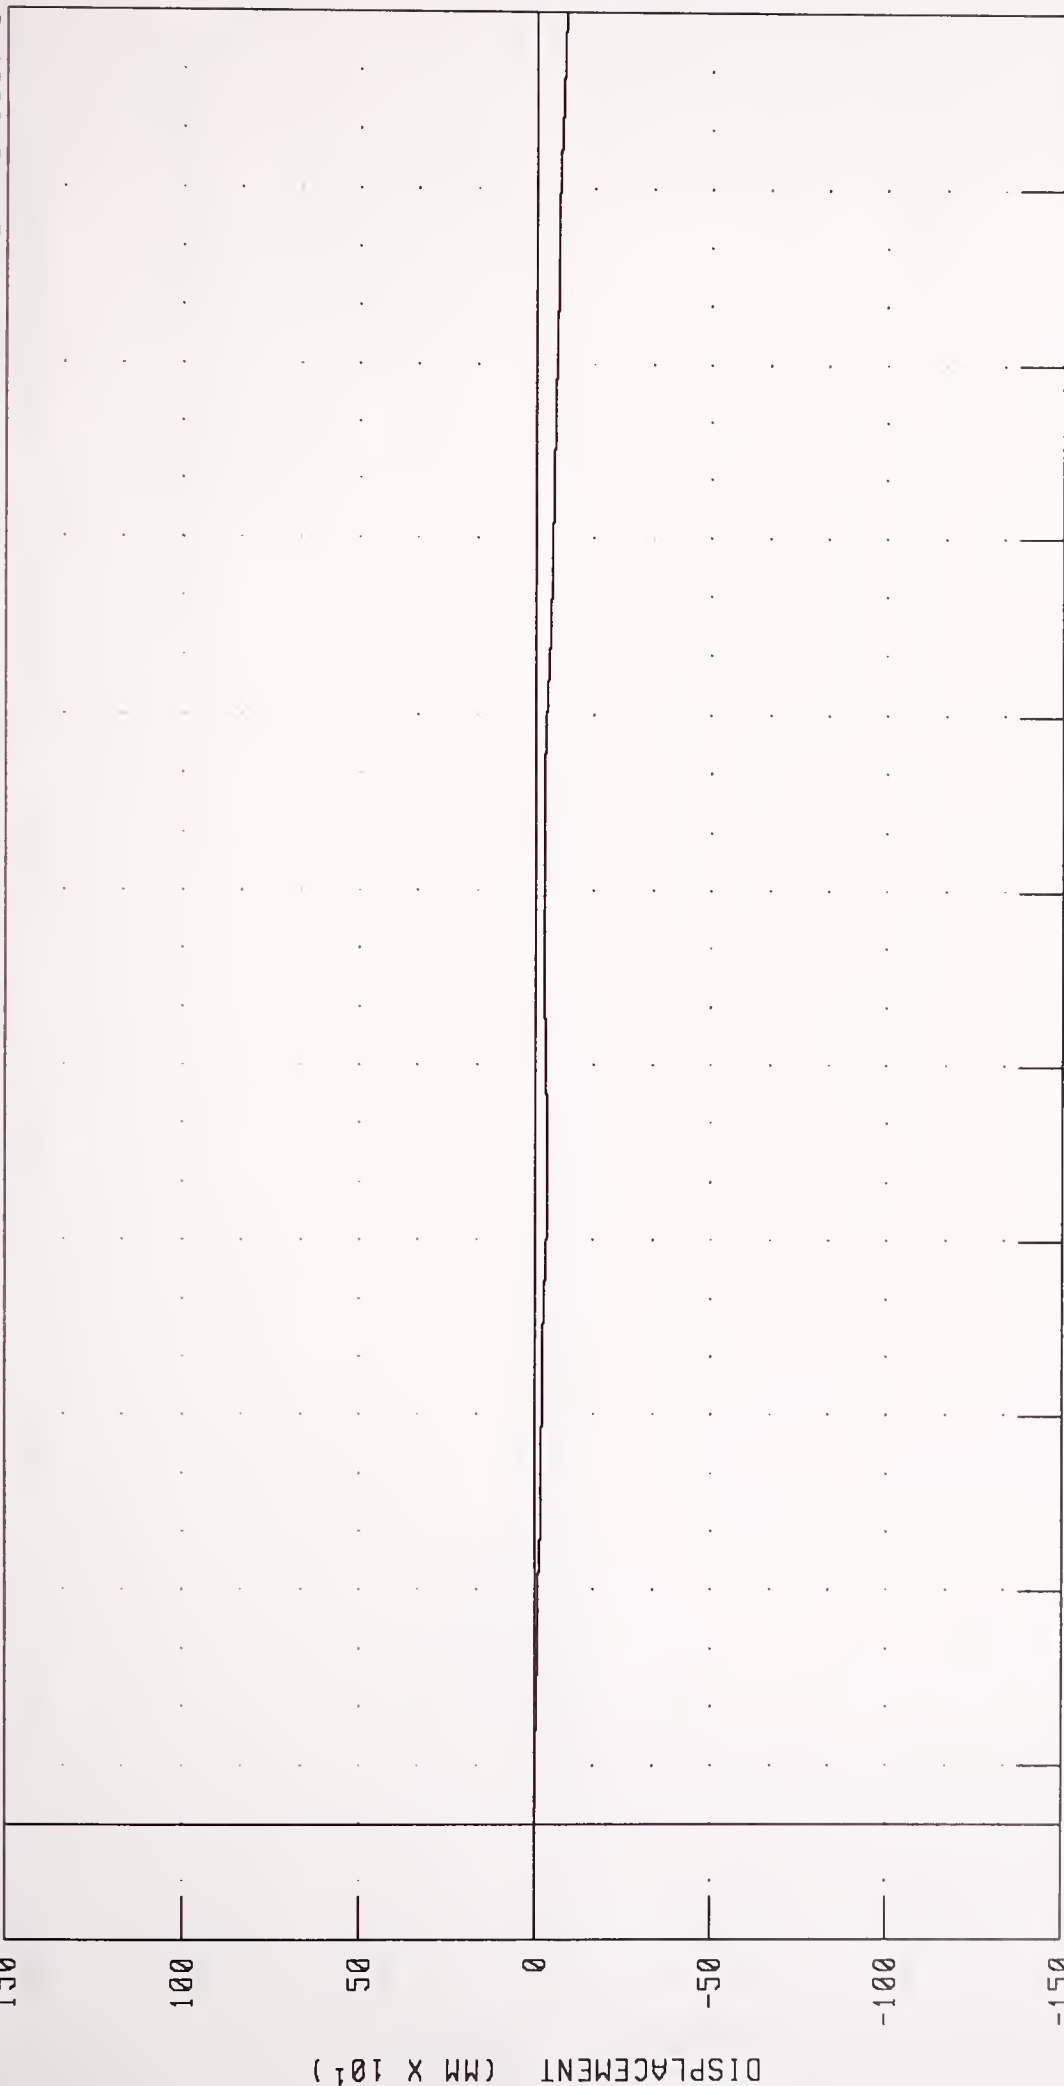
CHANNEL VCGZD1 FILTER CH. CLASS 180  
 PEAK DATA: 0.00 MM @ 0.00 MS; -84.15 MM @ 310.00 MS
